TECHNICAL INSPECTION REPORT

(6) OPERATION CROSSROADS,
U.S.S. YOG 83.
TEST ABLE [U].

OPERATION CROSSROADS

DIRECTOR OF SHIP MATERIAL
JOINT TASK FORCE ONE

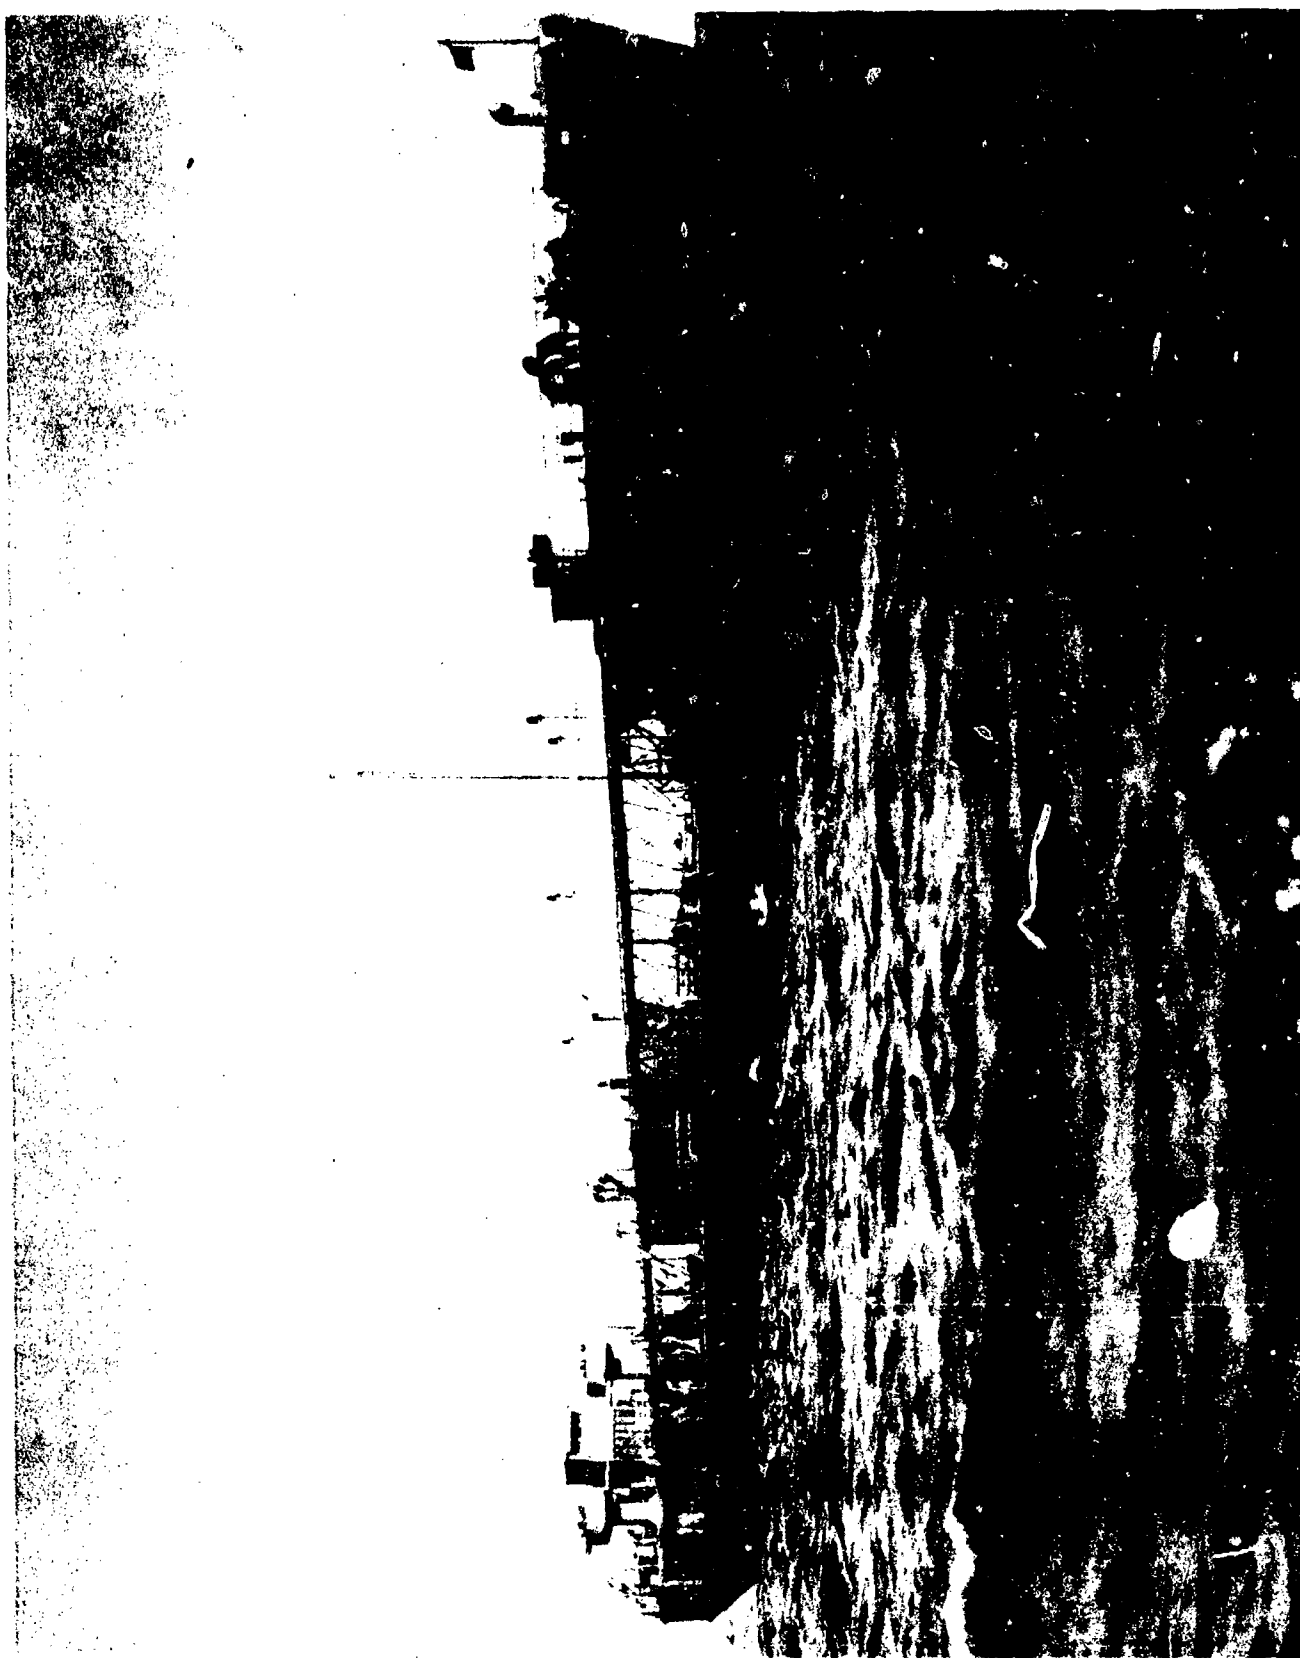
AA-CR-227-91-27. View from starboard bow after Test A.

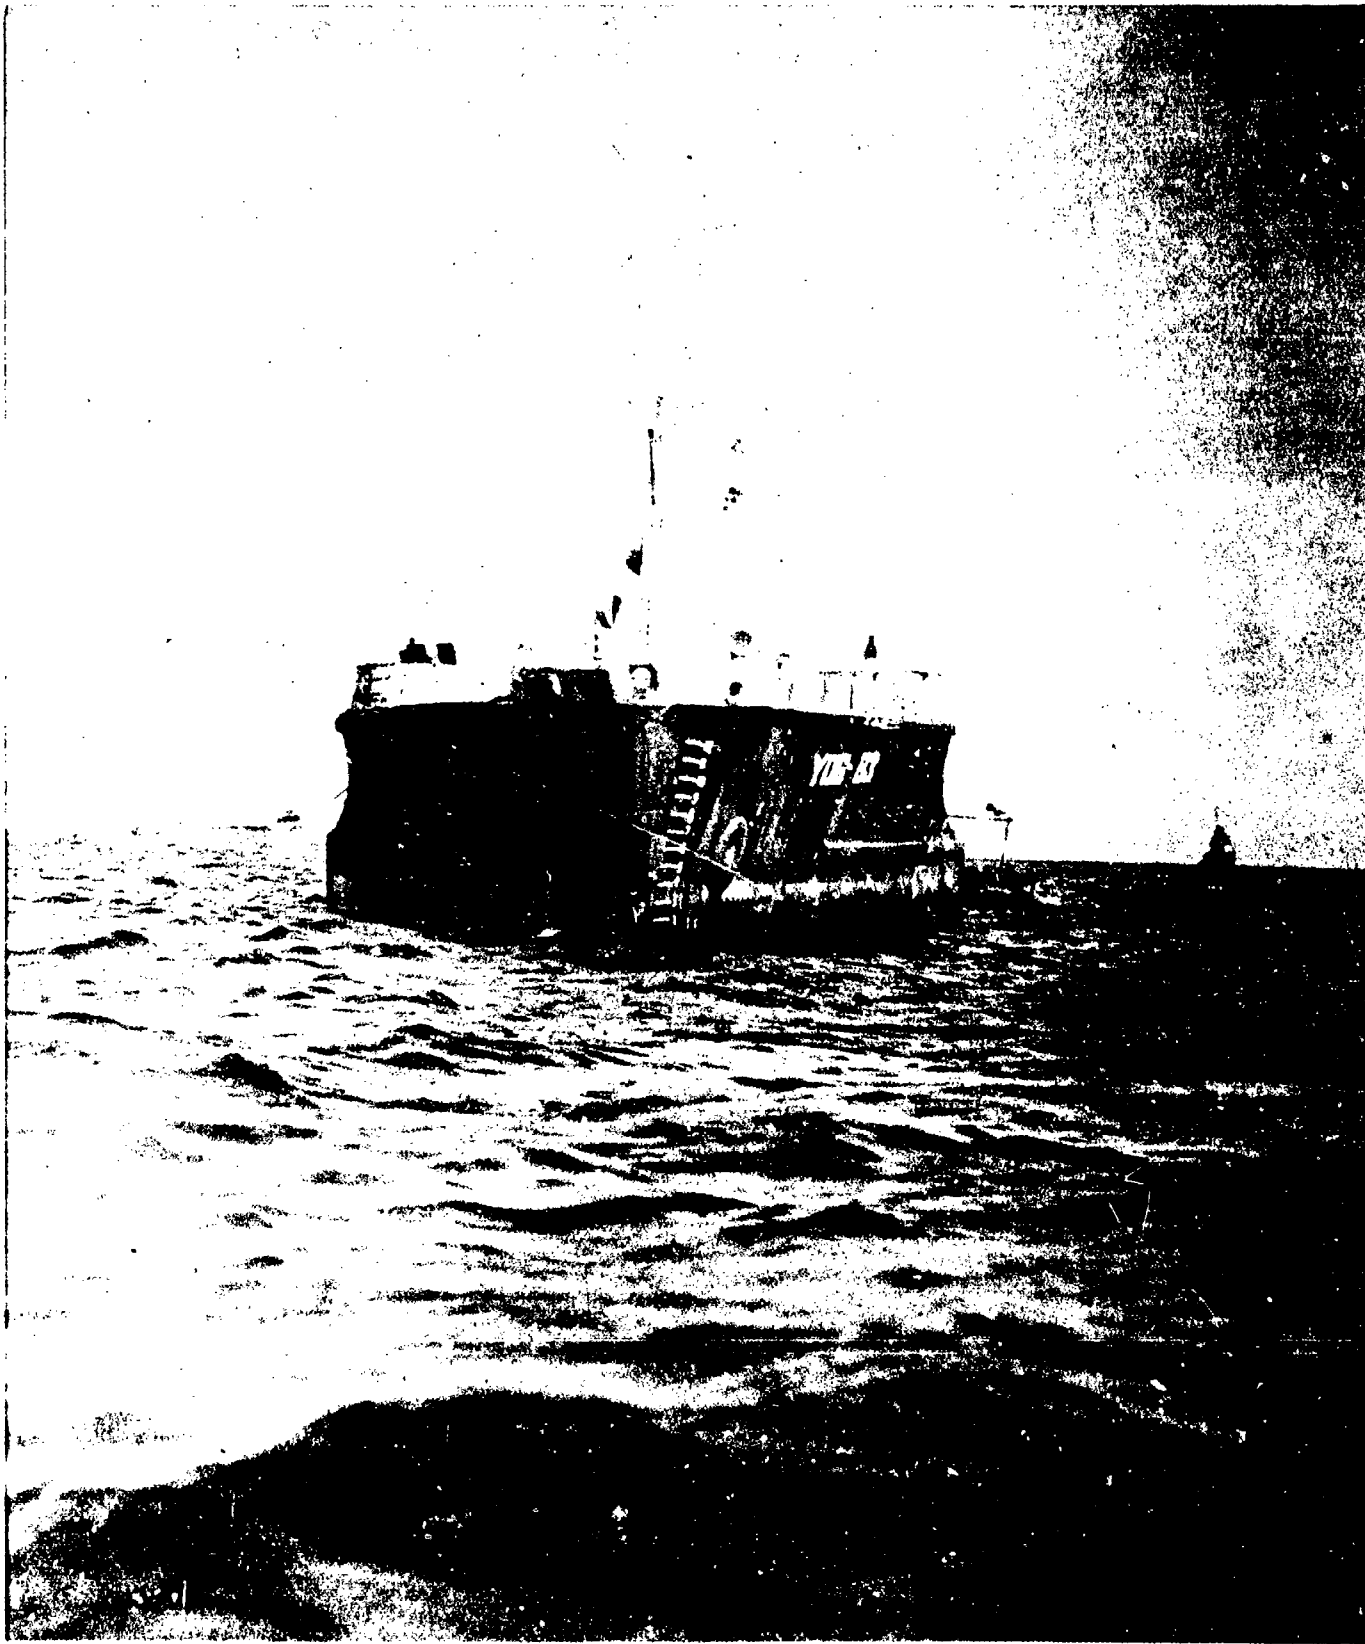
AA-CR-227-91-28. View from port quarter after Test A.

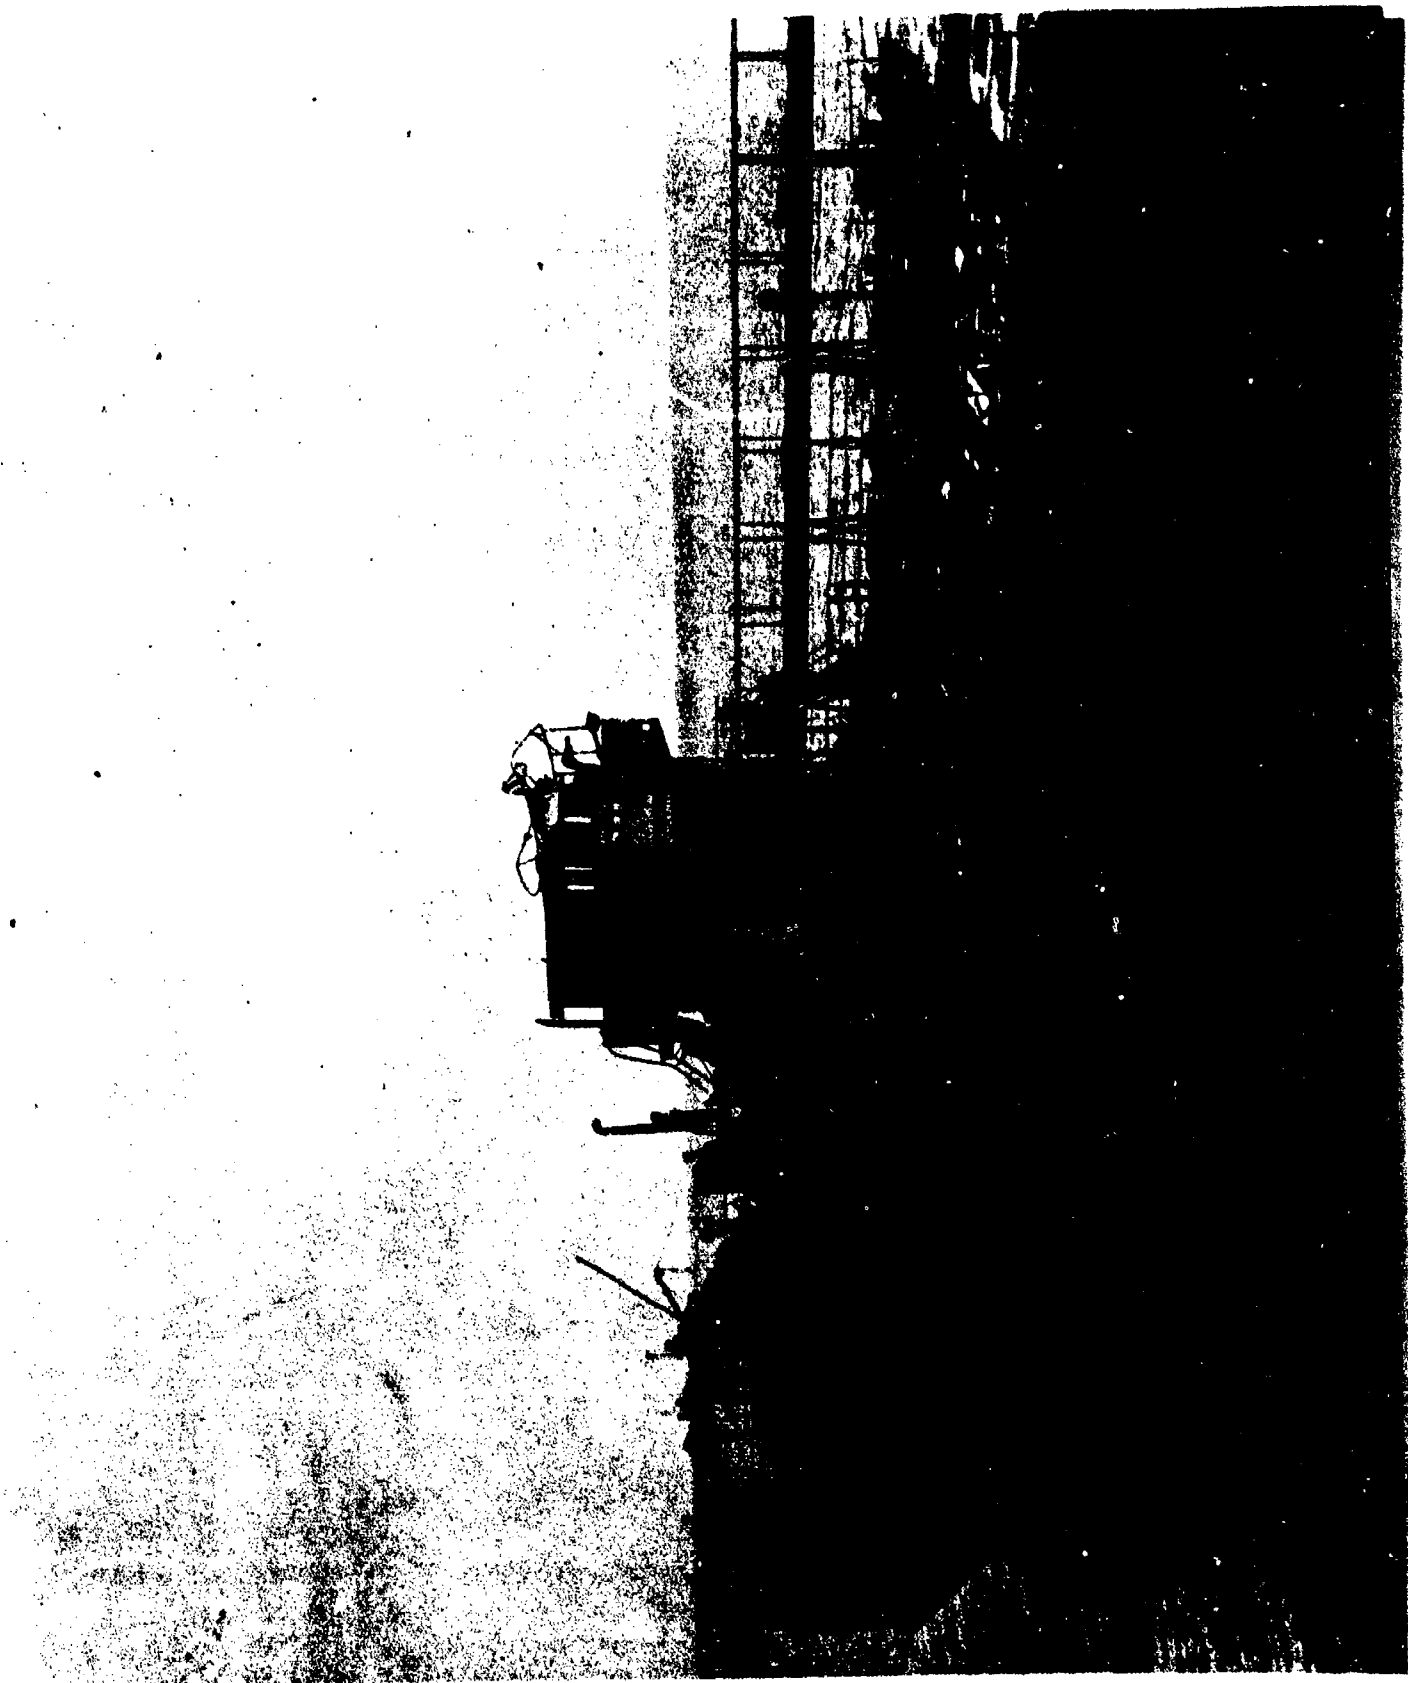
AA-CR-68-1744-4. After deck house from starboard.

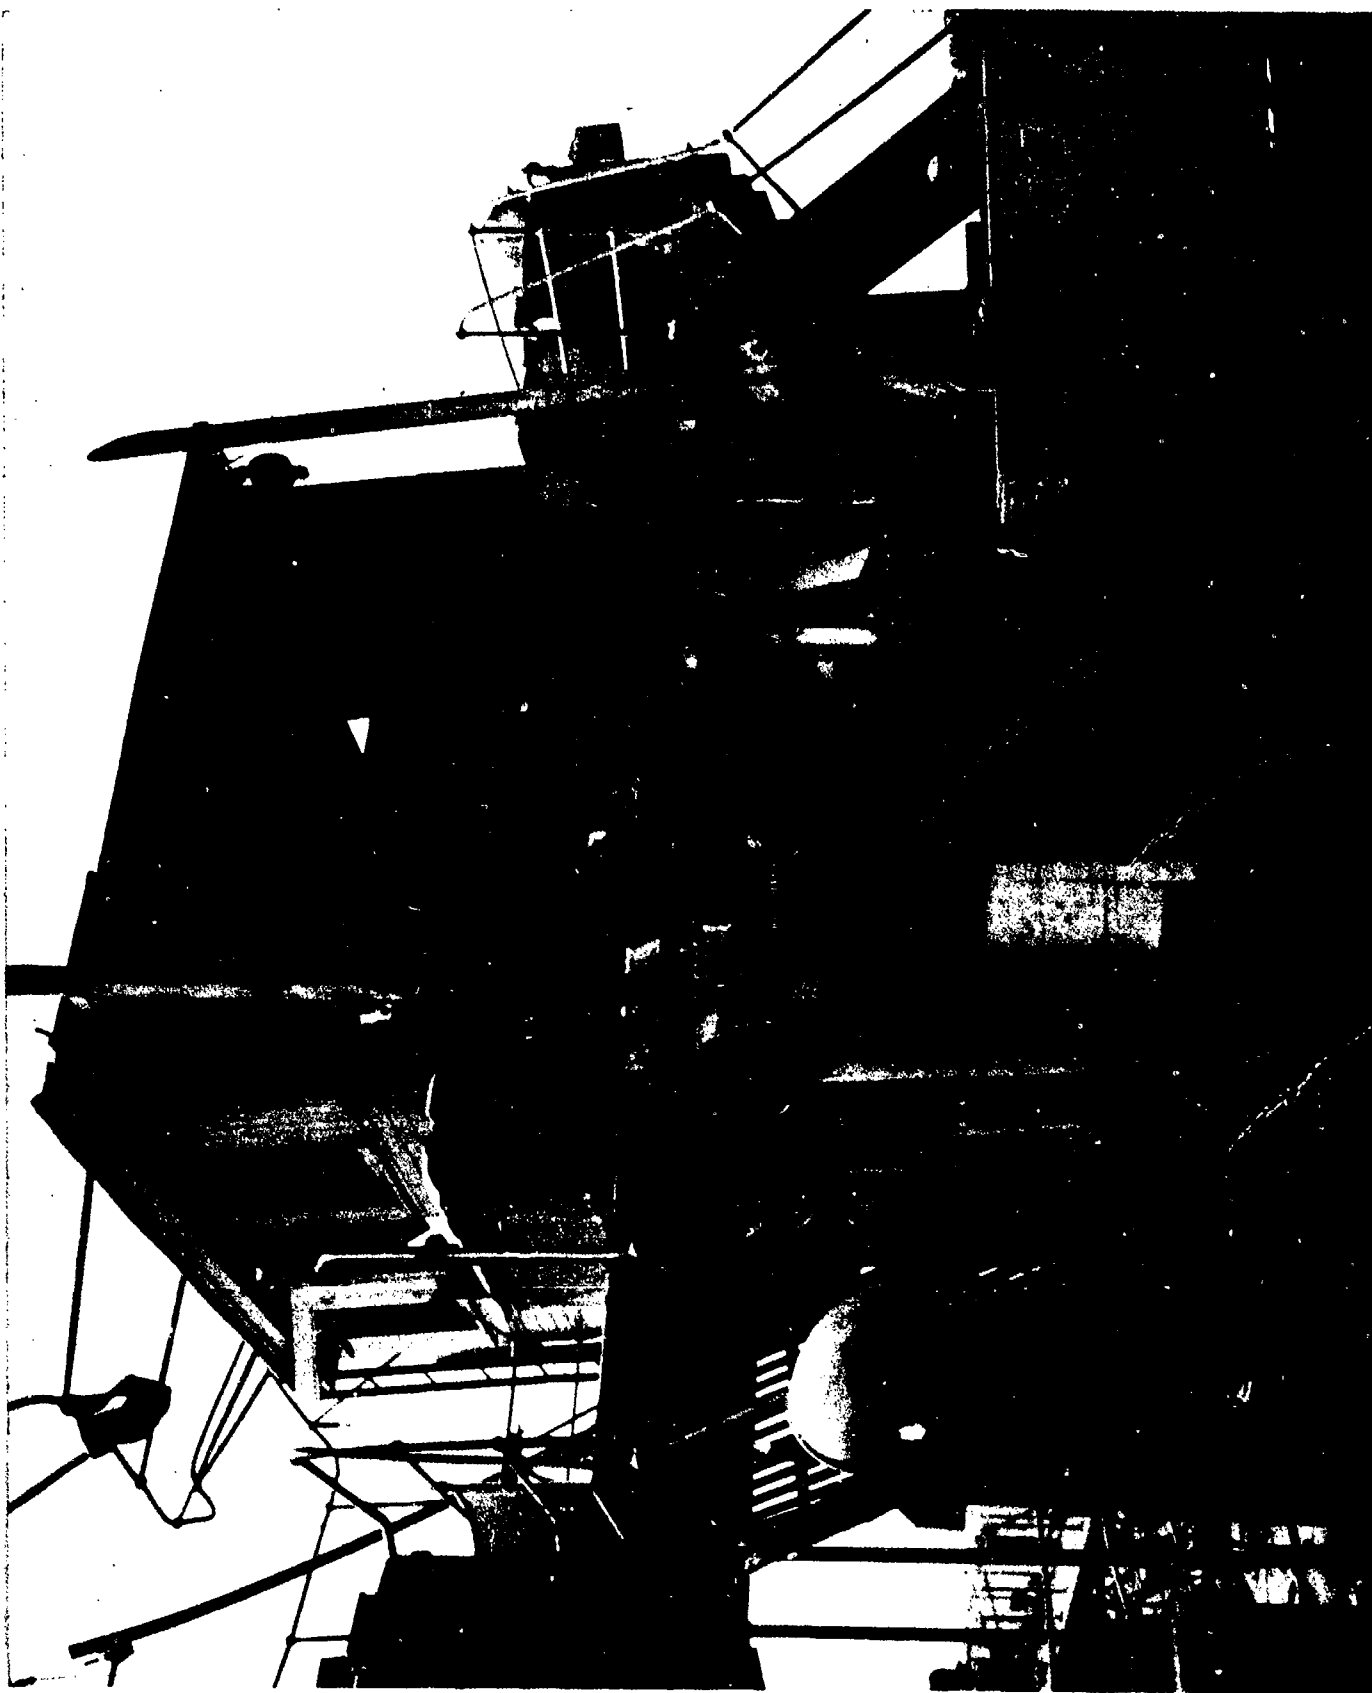
The wooden enclosure around the tank house is blown down (Photos 1829-7, 8, pages 41 and 42). The wheel house is intact but is twisted to port and forward. The pipe railing on top of the wheel house is blown down. The life raft frame on the starboard side of the poop deck is blown inboard and is pulled completely out of the foundation anchorages. (Photos 1744-10, 1829-9, pages 44 and 43). Cinch bolts and shear plates on this foundation pulled out of the concrete. The supports for the control box for the steering motor splintered the poop deck locally exposing the anchorage bolts and the reinforcing bars (photo 1744-8, page 45).

AA-CR-82-1829-7. Wooden bridge house, showing port and after sides.

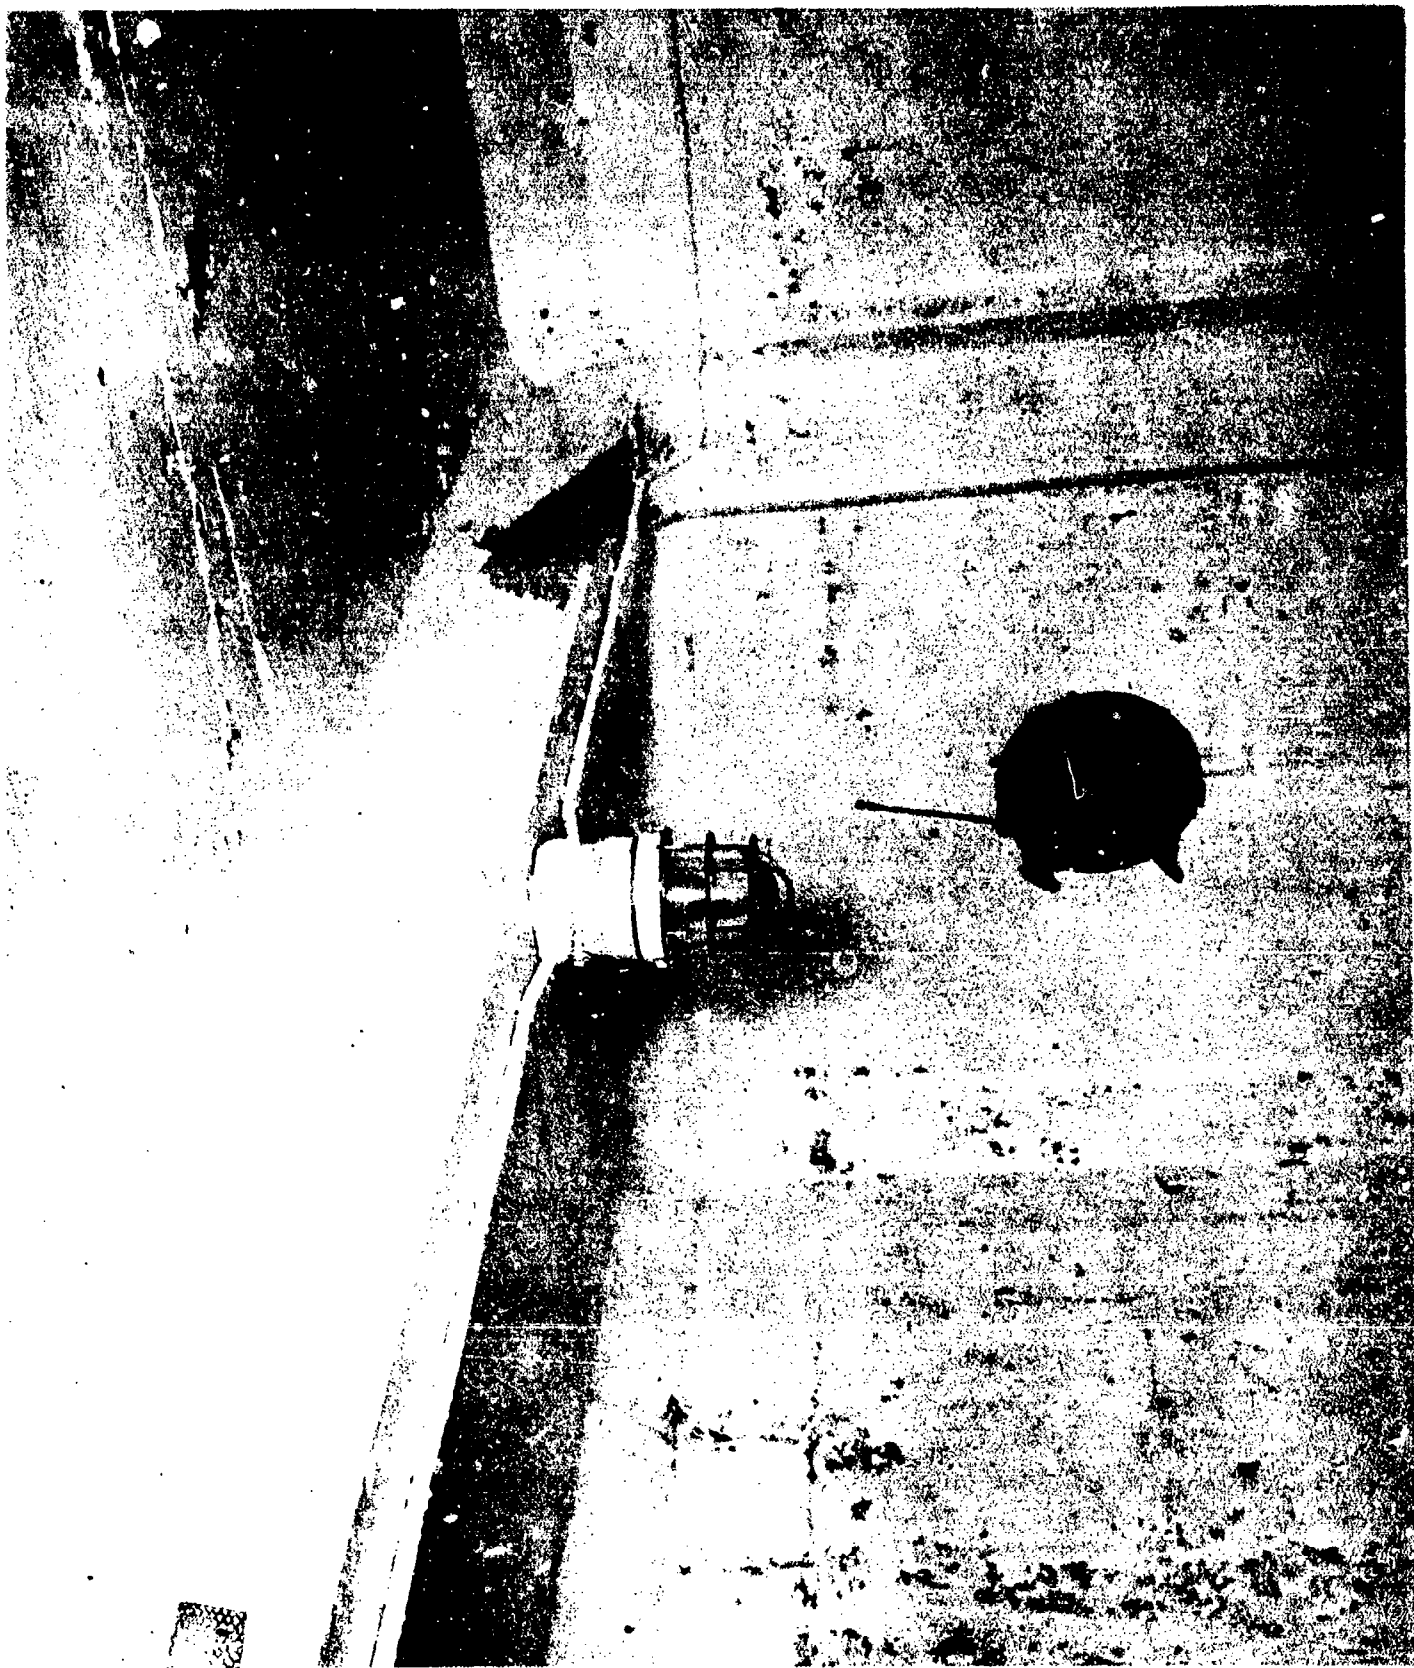
The pump house amidships, sustained minor damage to concrete. The three transverse deck beams are cracked near the splays with the vertical house side frames. (Photo 1829-6, page 46). The outboard beam is splintered in a diagonal direction.

The top of the pump room house has two transverse cracks approximately one foot away from each bounding transverse bulkhead. There is also a longitudinal crack on the port edge of the house top approximately at mid-length.

AA CR-82-1829-6. Deck beam of pump room house.
